Treatment of mild Peri-implantitis by Laser assisted Regenerative procedure

Dr. Bernard Dahan DCD
Moria Periodontal Center

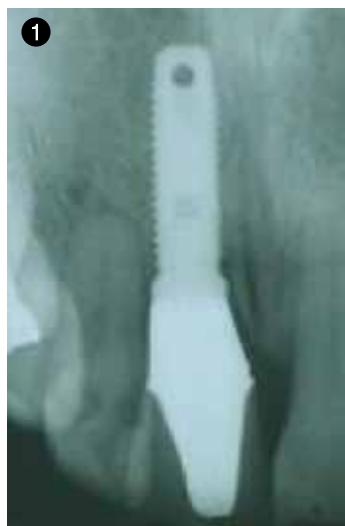
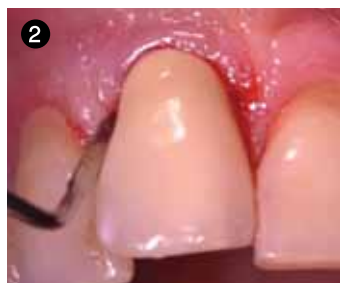
After examination, periodontal pockets (6-7mm) were found on the Bucco- distal aspect of the #11 implant without any XRays modifications (Pictures 1,2). No other areas were involved in this Localised Mild Peri-implantitis.

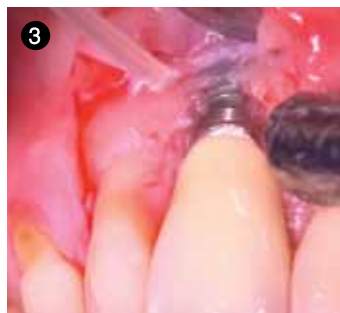
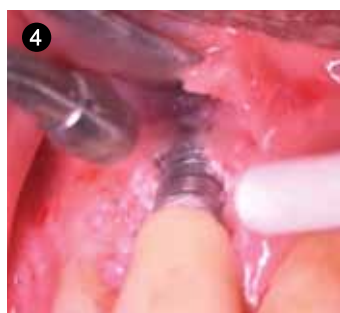
After debridement and exposure of the defect, decontamination of the exposed implant was performed by a combination of mechanical and Er YAG Laser therapy (50mj Energy/20Hz Frequency/Tip 1300 microns) (Pictures 3,4).

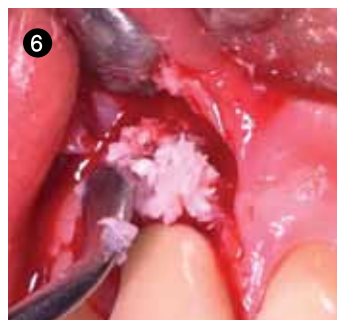
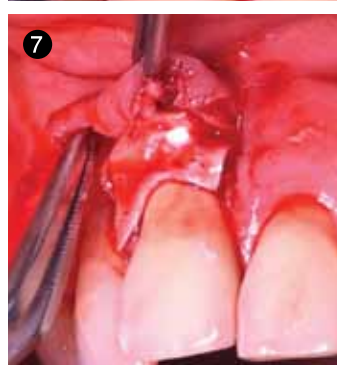
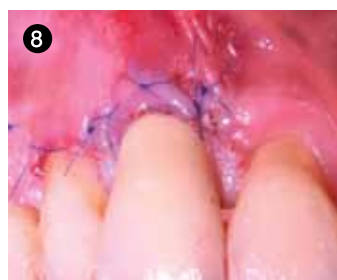
Bone Substitute (Xenograft),

Growth factors (Emdogain) and a Collagen Membrane was used to repair the defect. (Pictures 5,6,7,8) Several months later, the patient was asymptomatic and the clinical aspect was acceptable (No bleeding/No pocket) (Pictures 9,10). Because of the easy access for hygiene, the prognosis of this treatment of mild Peri-implantitis in the smile area can be fair.
